SPACE SHUTTLE PROGRAM
Space Shuttle Projects Office (MSFC)
NASA Marshall Space Flight Center, Huntsville, Alabama

STS-112/ET-115 Flight Readiness Review

External Tank Project

September 17, 2002

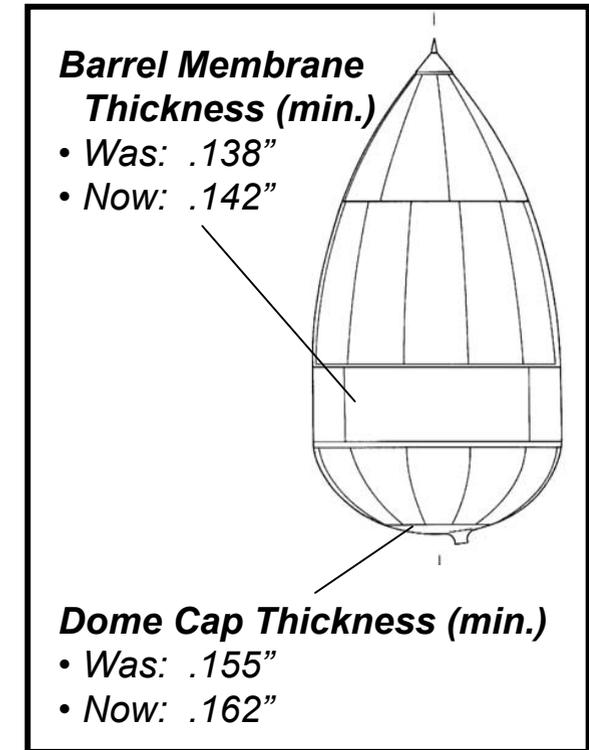
- Increased LO₂ tank barrel and dome cap pressure critical wall thicknesses
 - Thickness increase required to accommodate expansion of ullage pressure ICD requirement during late High-Q
- Increase in pressure requested to provide the Orbiter fleet the capability of using any combination of spare GO₂ fixed orifice flow control valves
 - 0.58 psig maximum increase in pressure occurs at t = 78 secs. for nominal mission
 - Ullage Pressure @ 78.0 secs. = 27.4 psia
- Pressure increase also required minor revisions to LO₂ tank proof test pressures and post-proof NDE requirements

- LO₂ tank membrane thickness changes are certified by similarity, proof test, and analysis
 - Basic geometry and material of hardware is unchanged
 - Proof test demonstrates a minimum of 112% of design limit load for critical location
 - Stress analysis shows adequate Factor of Safety for resized hardware
 - Min FS = 1.28 (FS req'd = 1.27) Barrel Wall Ultimate Tension

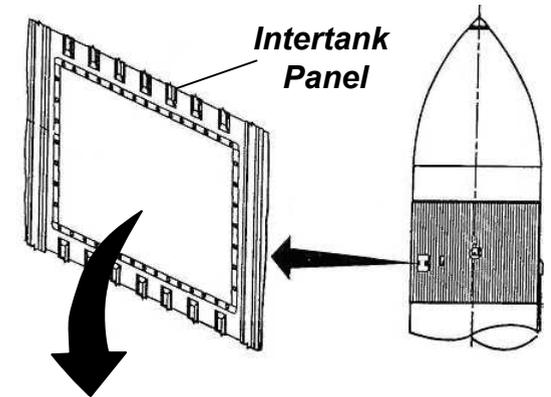
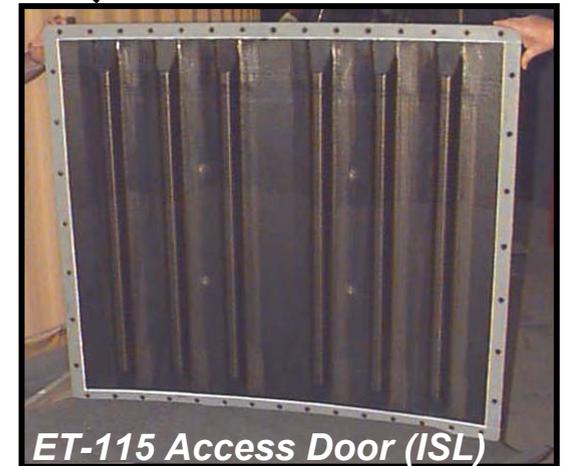
- Redesigned composite Intertank Access Door to implement a new material system
 - Replaced PMR-15 with AS4/3501-6 Graphite/ Epoxy composite material system
 - Commonly used material system with well-documented material property database
 - Much easier to process, but has lower strength at elevated temperatures
 - Configuration optimized by tailoring ply thicknesses to minimize weight impacts and improve design capability

- Design is certified by test and analysis
 - Structural and aero-thermal testing performed to verify the design
 - Structural testing demonstrated 342% of critical design limit load condition
 - Post-test ultrasonic NDE and cut-up examination showed no indications of delamination or imminent failure
 - Stress analysis shows adequate Factor of Safety for the redesigned door
 - Min FS = 1.57 (FS req'd = 1.40) Ply Tension

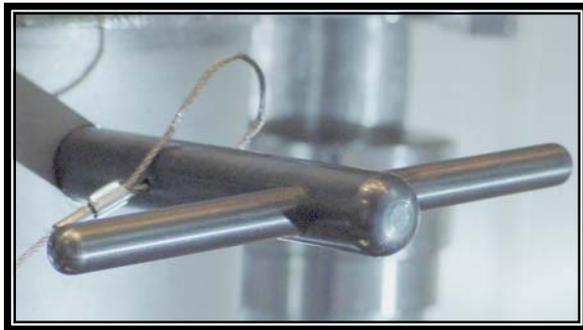
- LH₂ tank aft dome membrane damaged during preparations for post-proof tank cleaning

- During assembly of the wash probe, the tether on one of the disconnect pins failed resulting in the pin dropping the full length of the tank and impacting the aft dome
- Wash probe is a two part assembly joined by two disconnect pins (16.5" long x 5/8" dia.; 2.2 lbs)

Disconnect Pin with Tether

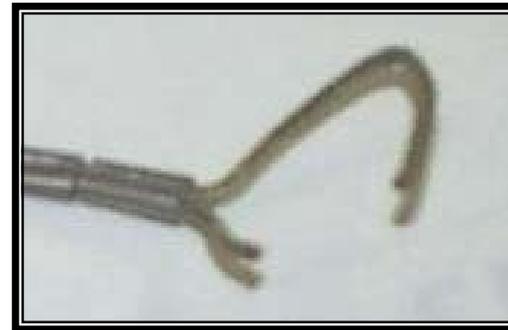
Failed Tether

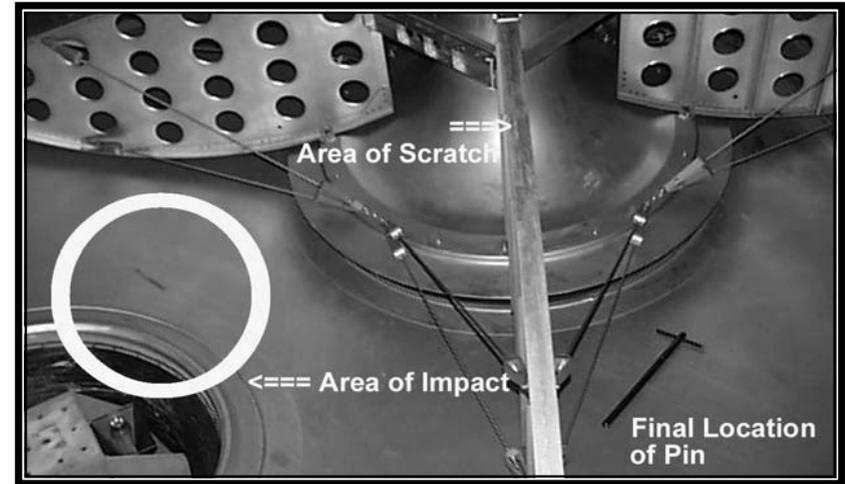
- Detailed internal inspection showed that damage was isolated to the aft dome cap and anti-vortex baffle
 - Total of 13 impact sites identified with 6 having indentations or raised metal and 2 having slight OSL protrusions (.007" maximum offset)

- Primary damage occurred in thicker areas of the dome cap
 - All visible damage was blended and sanded smooth
- Penetrant and radiographic inspection revealed no external or internal defects
 - Fracture analysis of hypothetical flaws, equal to the penetrant detectability limit in length, shows mission life greater than 400
- Stress Analysis shows a Factor of Safety of 2.04 (FS req'd = 1.26) for Ultimate Tension and Bending

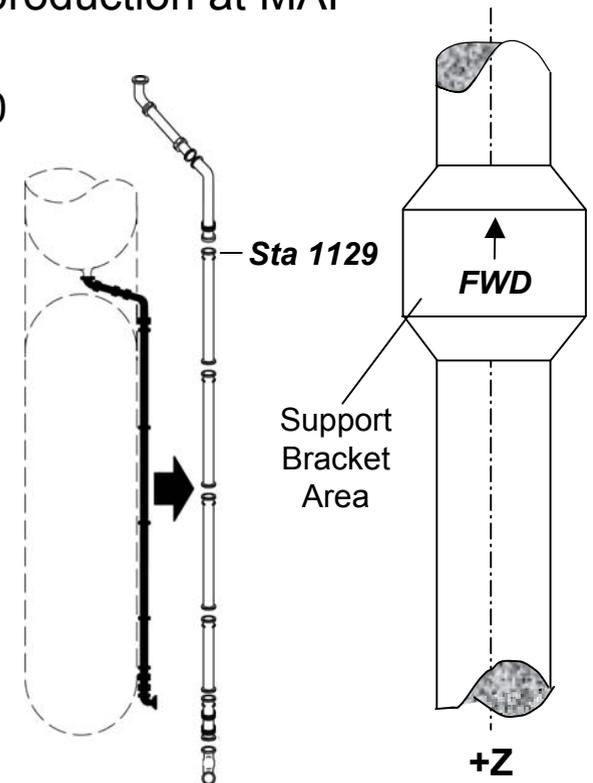
- Repair performed on LO₂ feedline foam insulation (BX-250) at Sta. 1129
 - Repair required based on foam insulation bond-adhesion (plug-pull) test evaluation

- All LO₂ feedlines using BX-250 material required plug-pull test evaluation based on investigation results of debonded material identified during production at MAF
 - Cause was isolated to unique production processing of the support bracket regions of LO₂ feedline sections with BX-250

- Performed plug-pulls on ET-115 feedline sections
 - Plug pulls at 3 of 4 stations were acceptable
 - Lowest value of 33.7 psi (35 psi required) accepted based on analytical assessment and past flight performance
 - Lower strengths previously accepted (12.7 psi min) and flown for locations on ET-112 and ET-113 with no issues
 - Plug-pulls at Sta. 1129 indicated a foam debond and required repair

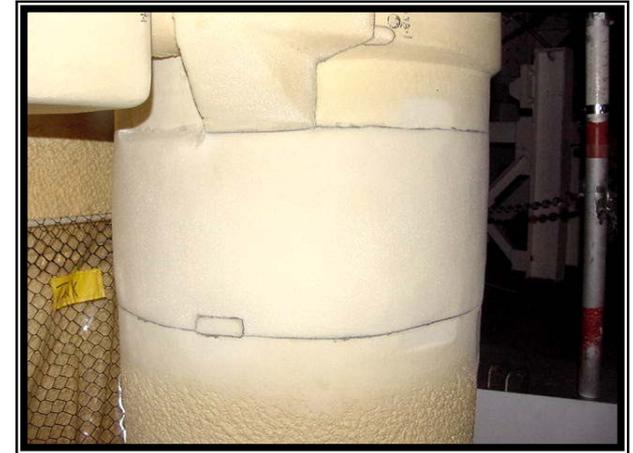
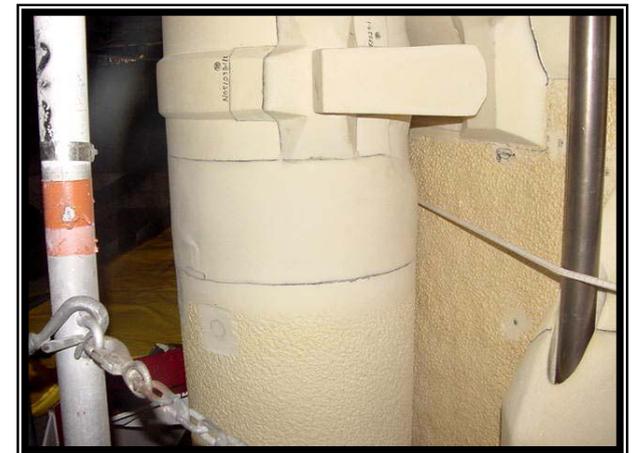
Repair size 8.6" long x 360°

- Repaired Sta. 1129 with a certified material (PDL-1034) and a validated repair procedure
 - Validation included four PDL pours at MAF using simulated geometry and orientation to represent logistics of tank at KSC
 - Performed cryogenic and room temperature plug pulls to verify application integrity
- Thermal and stress analysis performed to verify PDL performance in this application
 - Stress analysis shows FS >> 2.0 for foam loss
 - PDL provides adequate thermal protection for the substrate material
 - No change to substrate temperature or rupture altitude requirements
